Analysis of the failure of a PPS polymer cycling support: Microscopy and Finite Element studies

J. Marsh, R.P. Turner*, M. Wang and M.J. Jenkins

School of Metallurgy & Materials, University of Birmingham, Edgbaston, Birmingham, United Kingdom B15 2TT

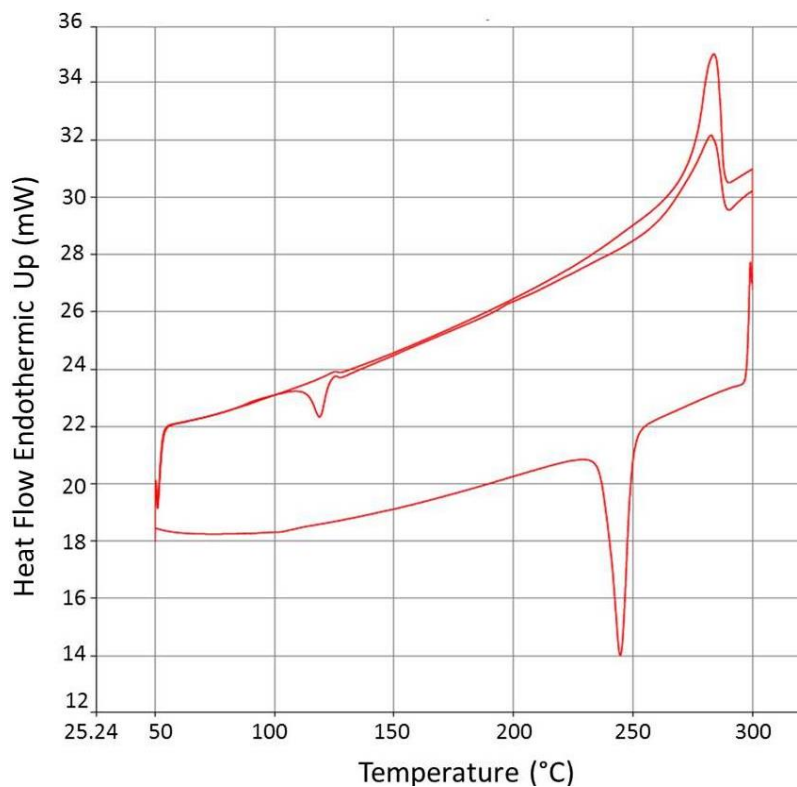
Figure 3: DSC trace of PPS GF30

A Perkin Elmer DSC7 was interfaced with a personal computer to measure thermal properties of the composite. The differential scanning calorimeter (DSC) was calibrated using known masses of indium (99.999% pure) and tin (99.999% pure). The composite sample of PPS GF30 (30% glass fibre) was tested using a DSC to determine its thermal properties. A 17 mg sample of PPS was subjected to a heat-cool-heat scan between 50 and 300°C at 10°C/min. Crystallisation and melting temperatures were recorded as 282.9 and 244.8°C respectively. Injection moulding components are cooled rapidly to increase production. This rapid cooling prevents the completion of non-isothermal crystallisation. An exothermic peak at 118.9 °C shows this incomplete crystallisation during manufacture (see **Figure 3**). The mechanical properties for the reinforced PPS material were obtained from the literature [15], and can be seen in **Table 1**.

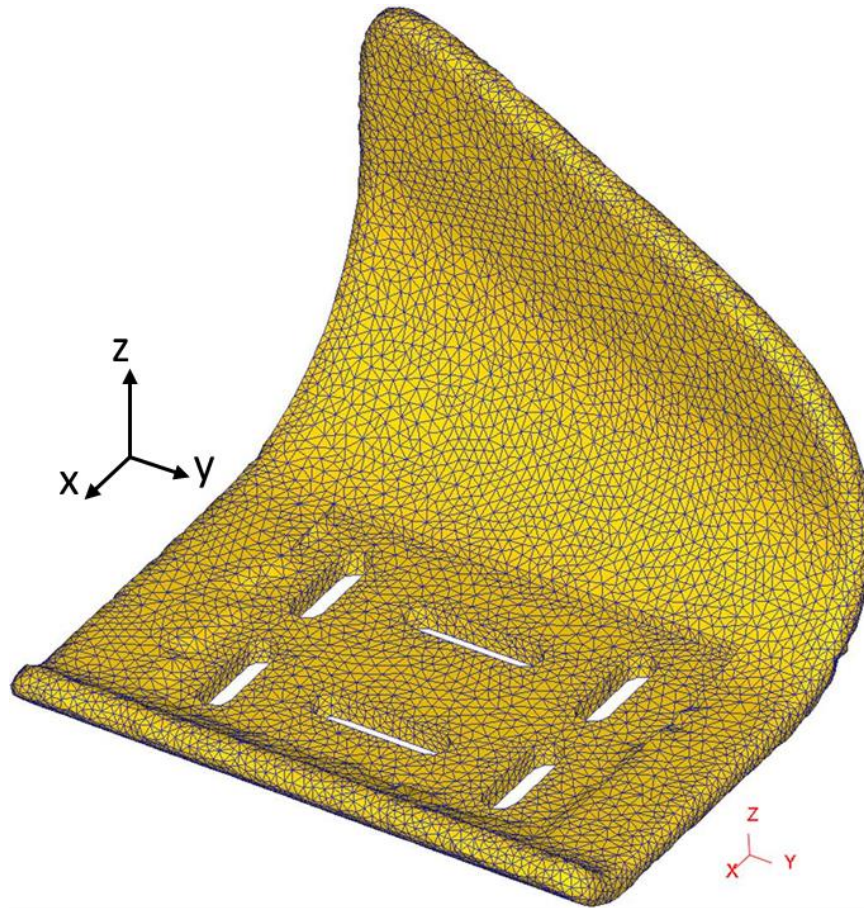
Figure 5: The cycling support arm-rest component, imported in to FE software Deform v11.1 and meshed with the automatic meshing tool

A finite element (FE) model was created, using general Finite Element solver Deform v11.1, to better understand the plastic strain and residual stress fields developing within the component, during the loading scenarios that were considered likely based upon the service and the crack surface. The model was constructed from the .step CAD files provided by the manufacturer. The model was set-up in a full three-dimensional environment and computed on a 48Gb RAM, 8-core workstation – although the model was run only on a single core. The model was meshed using the standard tetrahedral meshing application of the DEFORM v11.1 code. The mesh that was used contained a reasonably uniform mesh density - although automatic meshing refinement produced finer elements at sharper radii of the component geometrical features - with approximately 100,000 tetrahedral elements, and with an approximate meshing element length of 1.5mm. The applied mesh can be seen in **Figure 5**.
